Re: Service Station Remodeling Project

4925 Sonoma Hwy. Santa Rosa, CA

Figure 1. Site Plan and Excavation Limits - Redwood Oil Service Station #101, 4925 Sonoma Highway, Santa Rosa, California

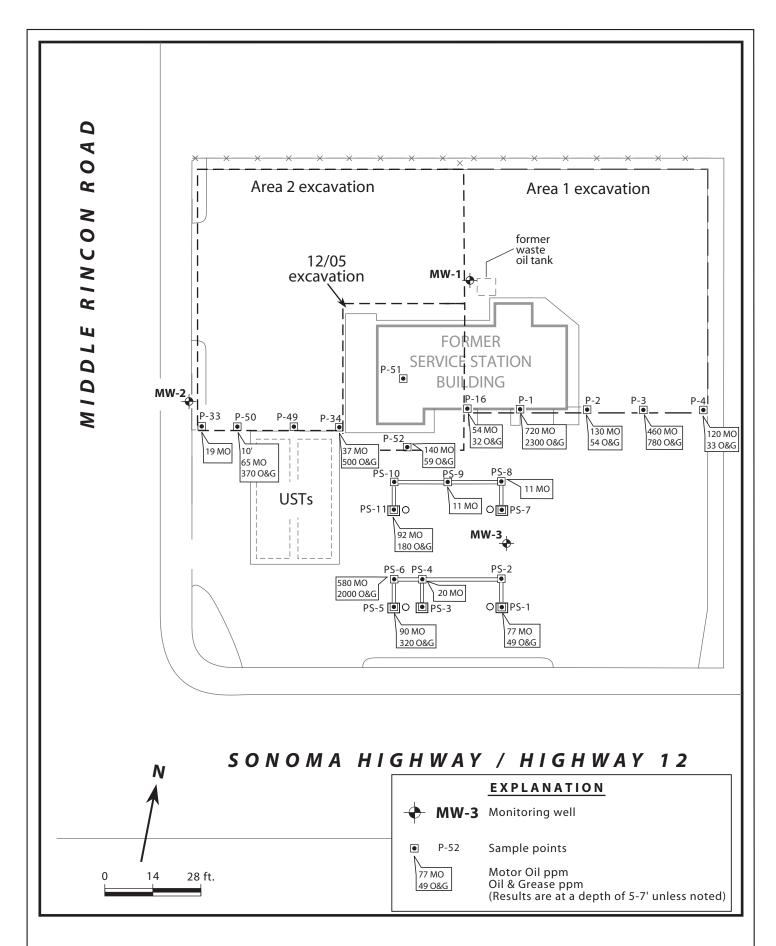
Figures 1 and 2 (attached) show all detections for samples collected during December 2005 excavation activities. The figures also show all detections for samples collected along the southern sidewall of the November 2004 and January 2005 excavations. Analytical results are summarized as follows:

- 1.) Most of the samples show elevated concentrations of Motor Oil (MO) and/or Oil and Grease (O&G).
- 2.) A few samples show detectable concentrations for hydrocarbons as gasoline.
- 3.) Only 2 samples (out of 21) had detectable concentrations of BTEX constituents.
- 4.) Only one sample out of 21 (PS-5) had a significantly elevated concentration of gasoline. No BTEX constituents were detected in this sample, indicating that this is probably older, weathered gasoline from which the volatile constituents have been degraded by natural causes.

- 5.) The results shown on Figures 1 and 2 are from approximately 3.5 ft to 5 ft bgs, sufficiently above the groundwater table to prevent the migration to groundwater of the heavy-end, immobile hydrocarbon constituents detected at the site.
